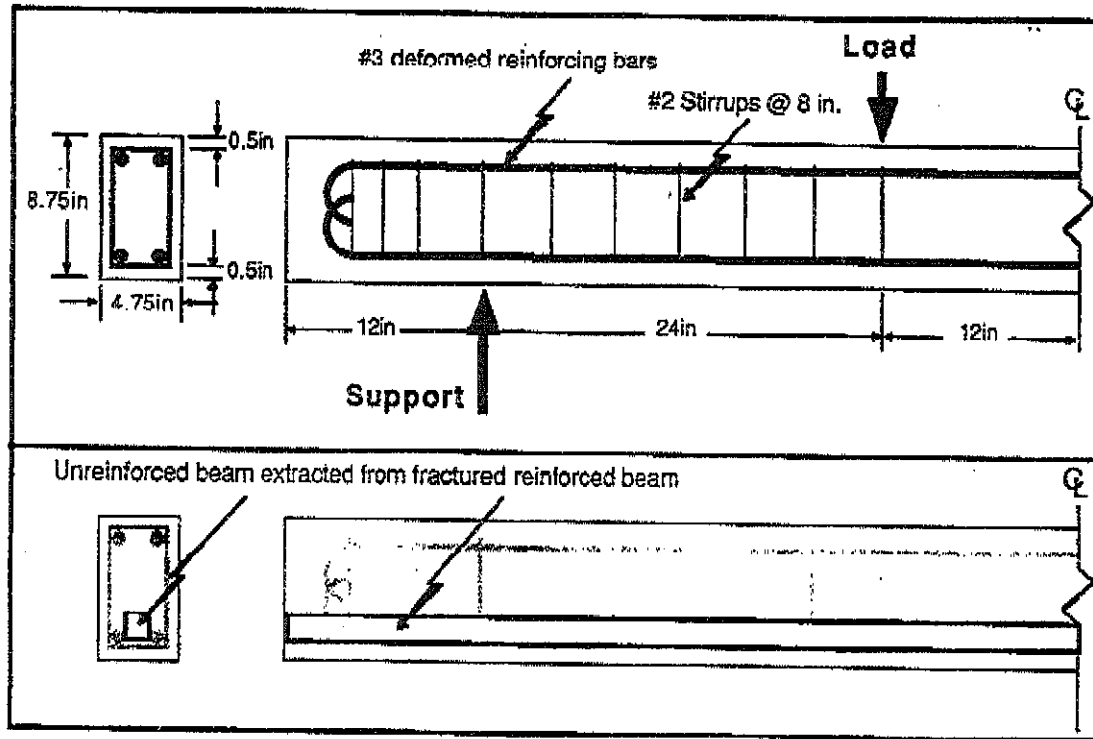
FIG. 1—Details of full-size reinforced concrete beams and unreinforced concrete beam which was cut out of the fractured beam. The unreinforced beam was later cut into small cubes which were used in the microscopic evaluation described in the paper.

The basic mechanical properties of the concrete are given in Table 2. An unreinforced concrete beam was extracted from the bottom of the failed reinforced beam (see Fig. 1) by cutting it with a diamond blade saw. The cutting process removed the reinforcing bars which were holding the cracked concrete together, and it was expected that the unreinforced beam will separate at the cracks. Upon examination of the cut surface, the cracks appeared to be filled with lighter materials with considerable strength, which allowed them to retain their integrity through the process of vigorous sawing and vibrating. The extracted beam was then cut into small cubes, approximately 2 by 2 in. (50 by 50 mm) using a slow action precise diamond blade saw. The cubes were tested for their density and ultrasonic pulse velocity and then capped and tested for compressive strength.
